Nesai Health

This test analyzes selected points to generate a comprehensive report. It detects the presence of silicone or permanent implants, identifies vacuolar implants such as hyaluronic acid, and assesses the overall skin condition.

Patient Info

Historic Clinic Number: 6707 Age: 64 years Skin Type: Type 2 Glogau Scale: Type 4

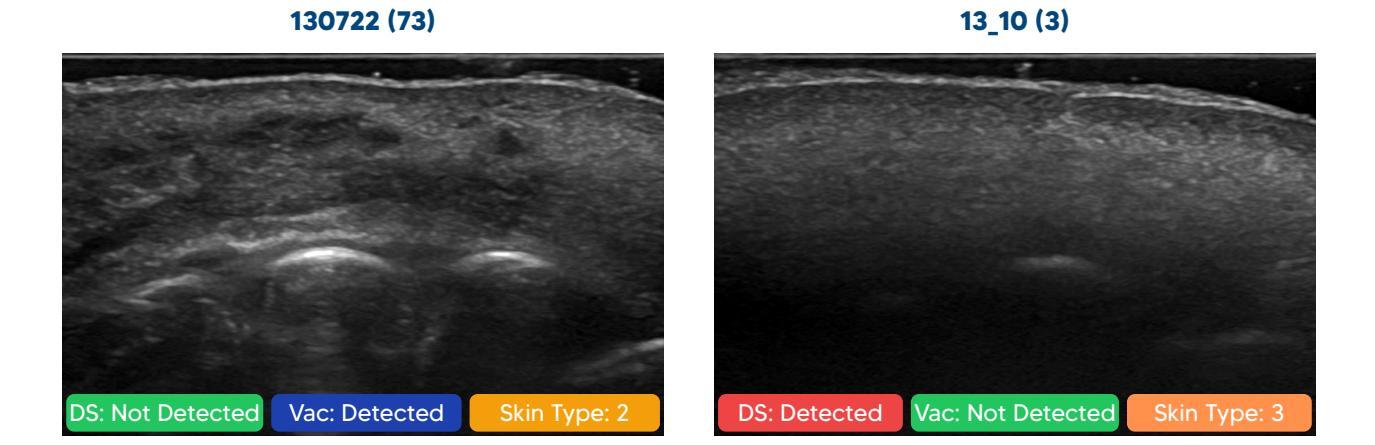
Analyzed Images

Ultrasound images of the facial zones analyzed by the Nesai Health platform.

- Echo Artifacts: Presence of artifact compatible with "snow pattern", a characteristic finding of permanent implants of polydimethylsiloxane derivatives, fluid silicone, and/or polymethylmethacrylate. This pattern suggests the existence of permanent synthetic materials in the evaluated area, requiring correlation with the clinical history.

- Morphological Patterns: Images compatible with vacuolar pattern, associated with treatments with non-permanent implants. The first diagnostic possibility is hyaluronic acid, given its frequent use in aesthetic procedures and its typical ultrasound profile. Other possibilities cannot be ruled out.

- Hypodermal Tissue: Changes of echogenicity in the hypodermal tissue, with modification of the underlying histomorphological structures. These findings suggest a moderate tissue reaction, without evidence of organized reactions (e.g., granulomas, fibrosis, or necrosis).

- Priority clinical correlation:
- Confirm history of permanent implants (breast, reconstructive, aesthetic surgeries) and treatments with hyaluronic acid.
- Rule out undeclared implantation, material migration, or interaction between permanent and resorbable materials.
- Follow-up:

- Ultrasound control in 3-6 months to monitor the evolution of tissue changes and the stability of the material.
- Clinical assessment in case of symptoms such as pain, progressive inflammation, or skin changes.
- Therapeutic management:
- Non-steroidal anti-inflammatory drugs (NSAIDs) or local corticosteroids if there are associated symptoms.
- Patient education:
- Inform about the importance of reporting history of aesthetic or surgical procedures.
- Monitor warning signs: increased volume, localized hardening, persistent erythema, or functional limitation.
